Docket No. 217 – Development and Management Plan Inspection

Northeast Utilities Service Company Certificate of Environmental Compatibility and Public Need for the construction of a 345-kV electric transmission line and reconstruction of an existing 115-kV electric transmission line between Connecticut Light and Power Company's Plumtree Substation in Bethel, through the towns of Redding, Weston, and Wilton, and to the Norwalk Substation in Norwalk, Connecticut.

Date: January 26, 2006

Location: Overhead Line (Composite 345kV and 115kV Gallows Hill to Archers Lane) and (345kV H-Frame Hoyts Hill to Gallows Hill)

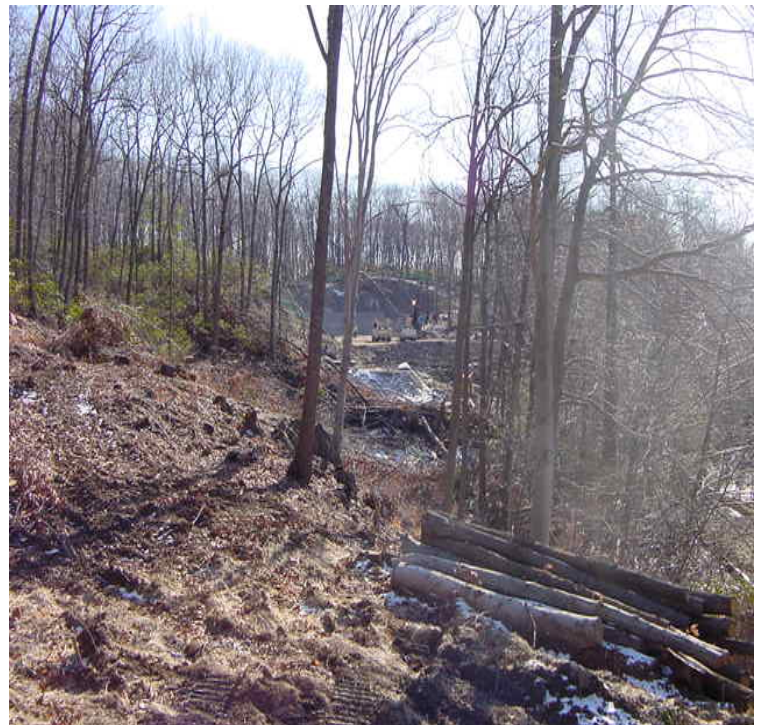
Photo on the left shows the first wetland crossing along the ROW access road where sediment from run-off has settled within the wetland. Solutions to improving the erosion controls here are needed. Photo on the right shows the view to the station from the ROW. 1/26/06
